Manhole Inspection Summary

Manhole # S27I__035MH

Location Address: **1016 W Pratt (alley behind house)**

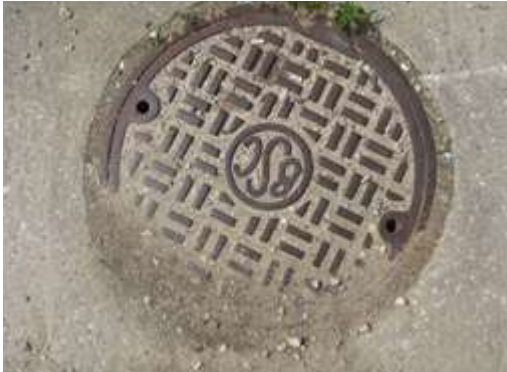
Cover View

Cover Shape: **Circular** Diameter: **25.** (in.) Length: **0** (in.) Dist A/B Grade: **0** (in.)
75

Type: **Sanitary** Condition: **Sound** Cover Material: **Cast Iron**

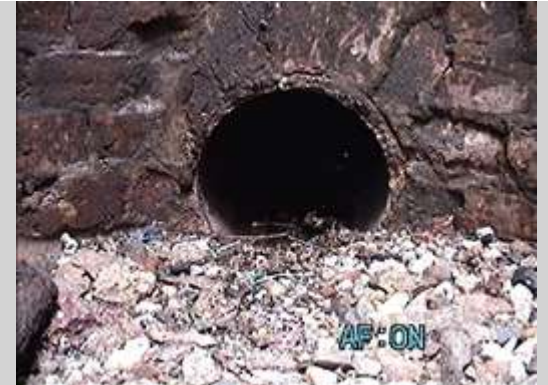
12 O'Clock Outflow

8 in. Circular Gravity Sewer
Pipe Out @ 12 O'Clock

Pipe Height: **8.4** (in.) Rod and Bar (Angled)

Pipe Material: **Clay** ☐ Pipe Lined

Infiltration: **None** Pipe Seal Cond: **Unknown**
